AT&T MIDTOWN  
CENTER

## TWO LIMITED ACCESS ROOF SYSTEMS, ONE A SKYSCRAPER, ONE A HIGH RISE, WITH A MYRIAD OF CHALLENGES.

# PROJECT BACKGROUND

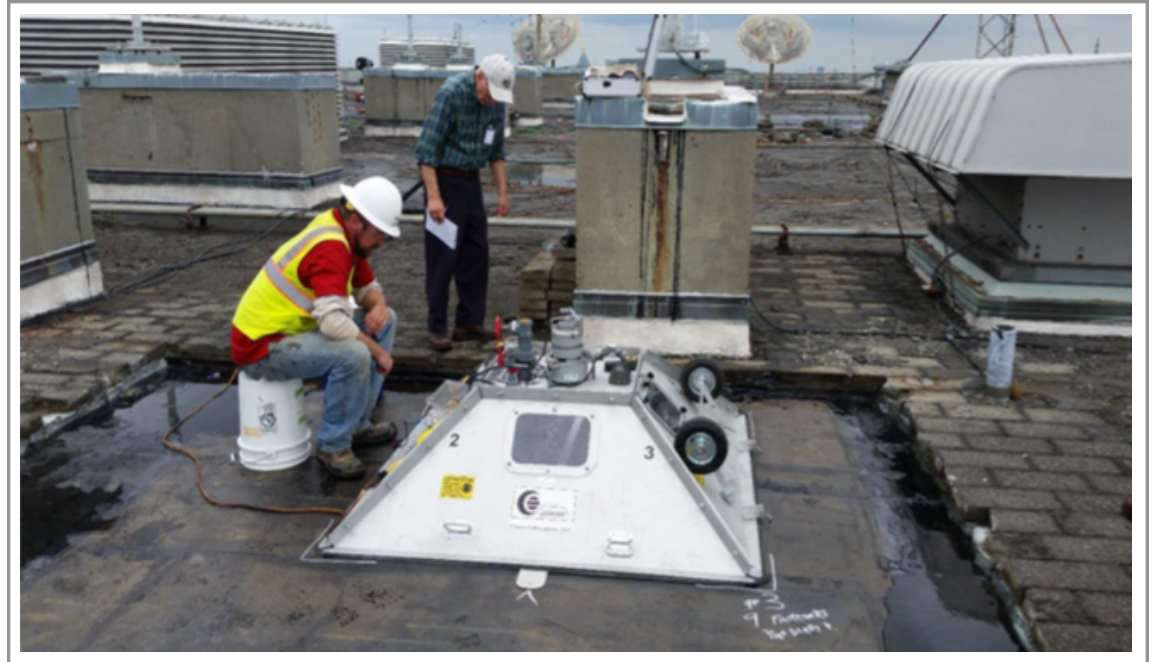
We recommended a hybrid system. That is a system comprised of a mechanically attached cement board with insulation and an adhered membrane.

In order to propose the hybrid solution, we had to address proper **wind uplift issues** in design. We engaged Dr **Rene Dupius**, PE PhD, to design and to conduct testing run by Terracon, Inc. on the proposed solution. Based on the American Society of Civil Engineering 7 - 10, wind uplift loads, Dr. Dupuis determined that the field needed to achieve an 74.3 minimum psf and the perimeter needed a 121.8 minimum psf (prior to adding a safety factor to this number). This system achieves these standards with the fastening pattern reflected in the detail drawings he created for this project.

We proposed to mechanically attach a 7/16” Dexcell cement cover board to the deck. Prep work included removing the limited coal tar pitch in areas where it wasn’t adhered. This meant bagging and then placing the bagged coal tar pitch into drums that were then sealed. The next layers were a torch applied APP smooth surface barrier membrane followed by two layers of twenty pound, 2” ISO insulation laid in low rise foam. Above that is a 1/2” HD cover board also laid in low rise foam. The top is a fully adhered 60 mil TPO membrane. This also meets the current R value per building code, that has changed considerably since the 1980s when the building was constructed. Additionally this allowed us to secure a 20 year, no dollar limit warranty.

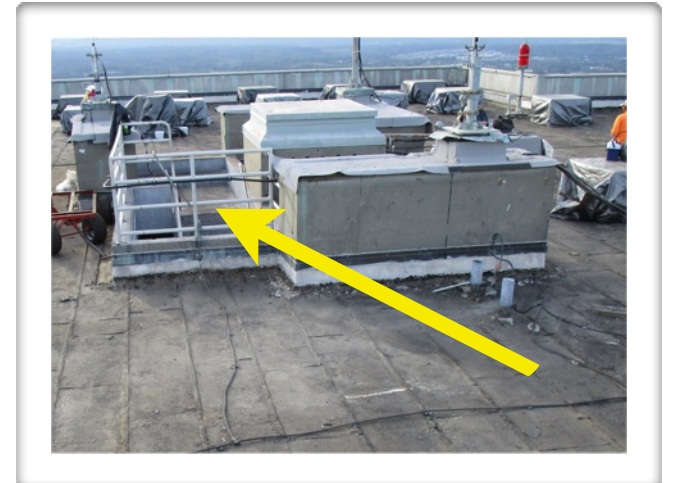
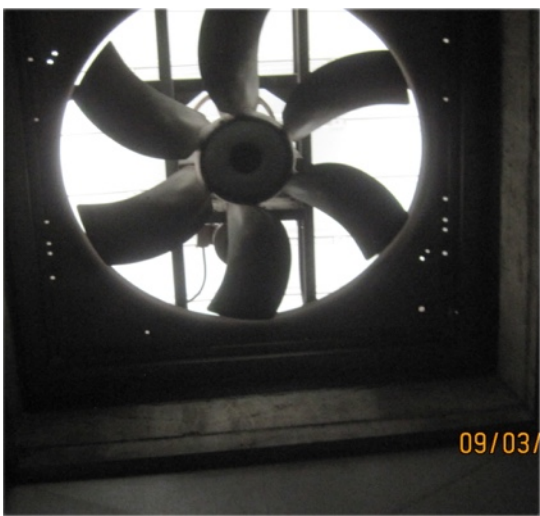
Creating the opportunity to efficiently move people and material through the limited access conditions was a challenge on this project. The roof system was only accessible through the small U-shaped stair case (see illustration) that was too narrow to transport supplies and waste. We found an opportunity through the **removal of a fan** which created a space that was approximately 5'x6' where we could hoist material.

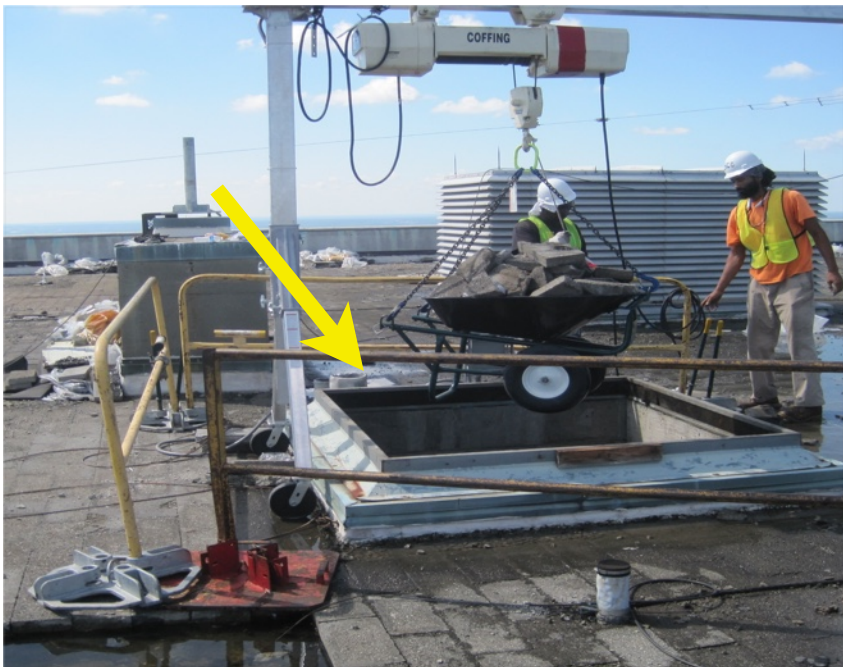
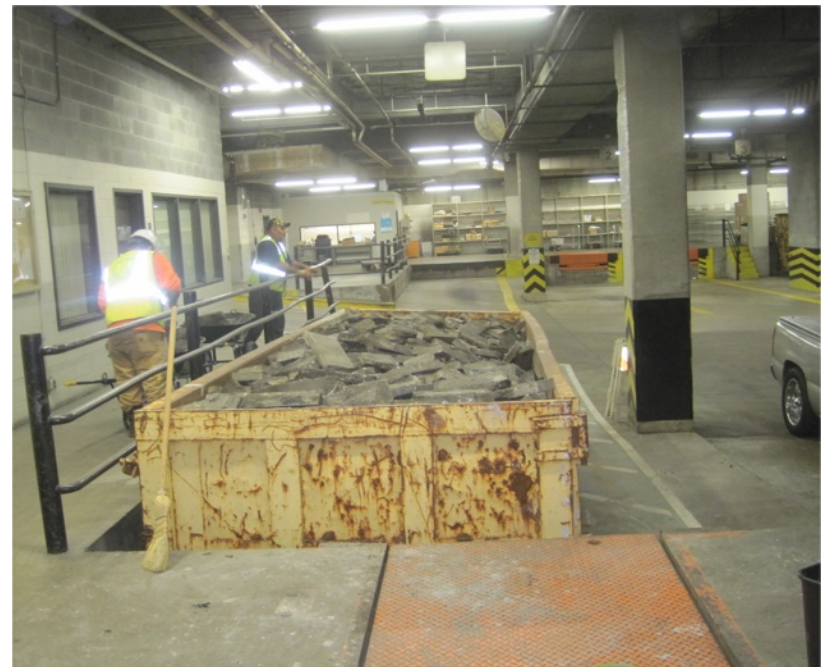
We positioned a two ton crane above the opening **HOWEVER** that only allowed us to move material to the 47th floor. **The freight elevator is located on the 46th floor.** We had to create a means by which we could smoothly move material an additional floor. The 47th floor had a crane in a different area that would allow us to hoist from between the 46th and 47th floors so we could load items, roll them to the next crane location and either up to the roof system, or down to the freight elevator. In order to prevent redundant handling of pavers, etc. we had **wheelbarrows customized** so that we could remove the handles (wheelbarrow total length was too long for the fan opening) and so that they had attachments for hoisting. (see illustration without handles for hoisting)

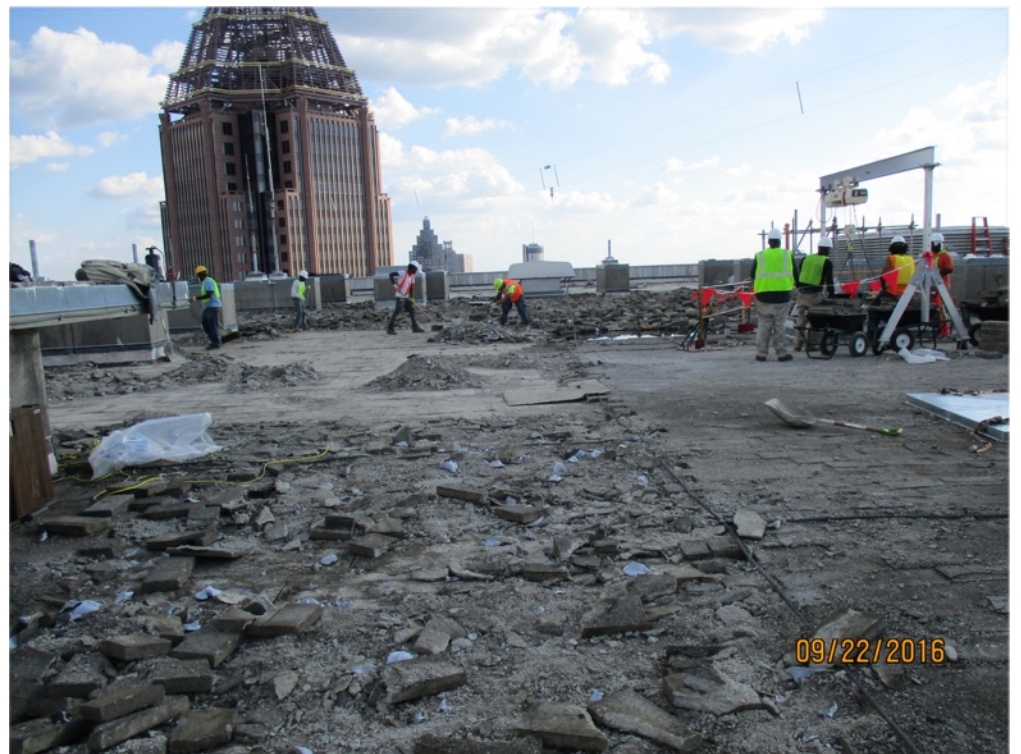
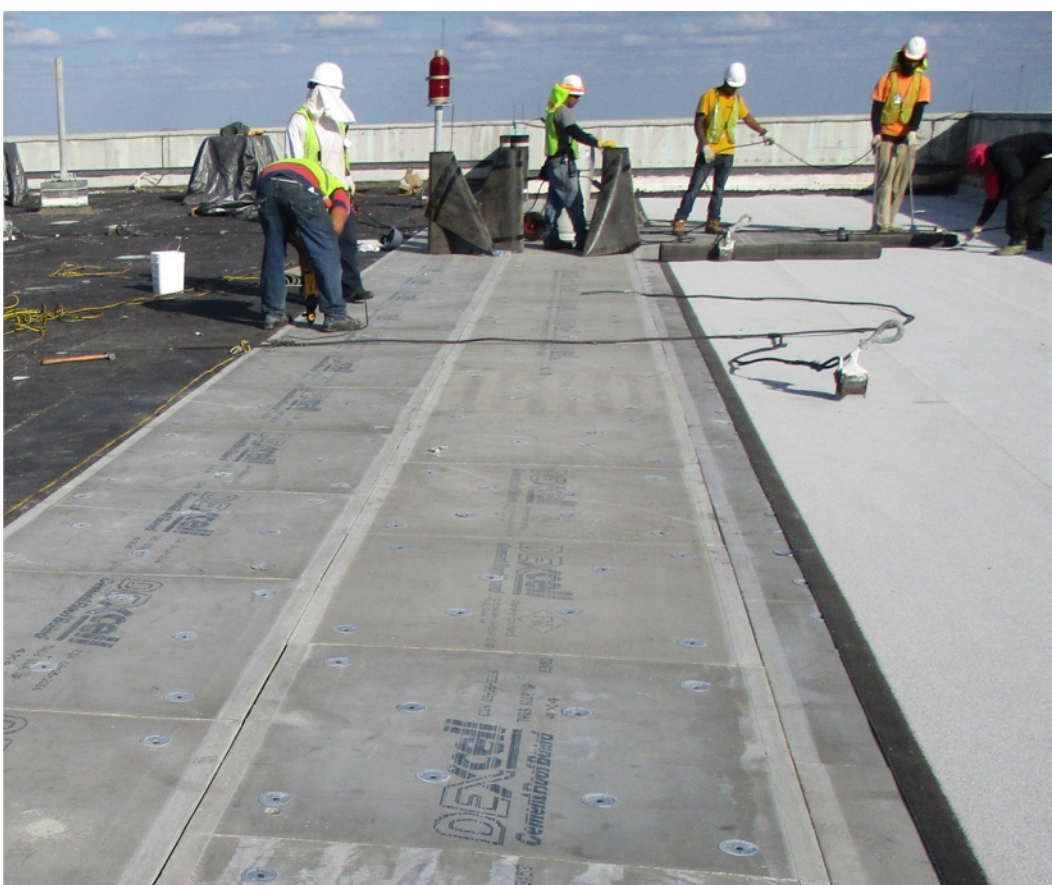
Next we repeated the same process to **remove the 2” extruded polystyrene insulation board**. We had to be careful as we did not want to disturb the coal tar pitch. The design called for only removing unattached areas and leaving as much of it in place so as to not create a situation where noxious fumes were pervasive in the building. The coal tar that was removed was bagged and placed in drums that were then sealed prior to removal.

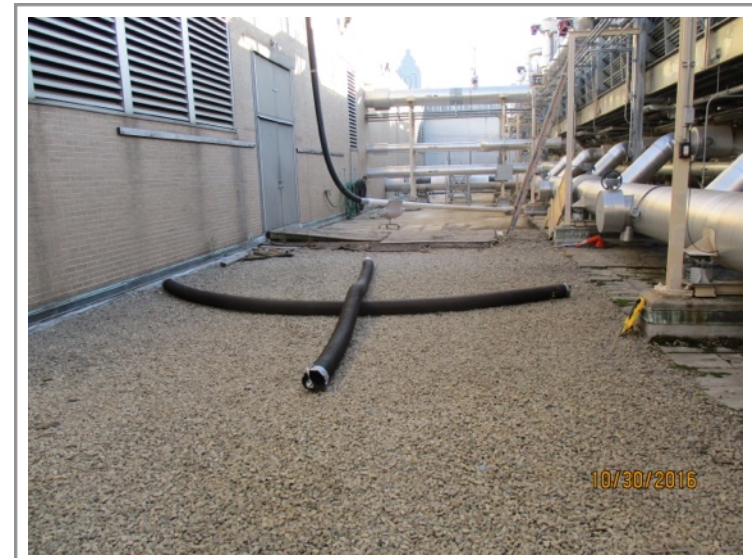
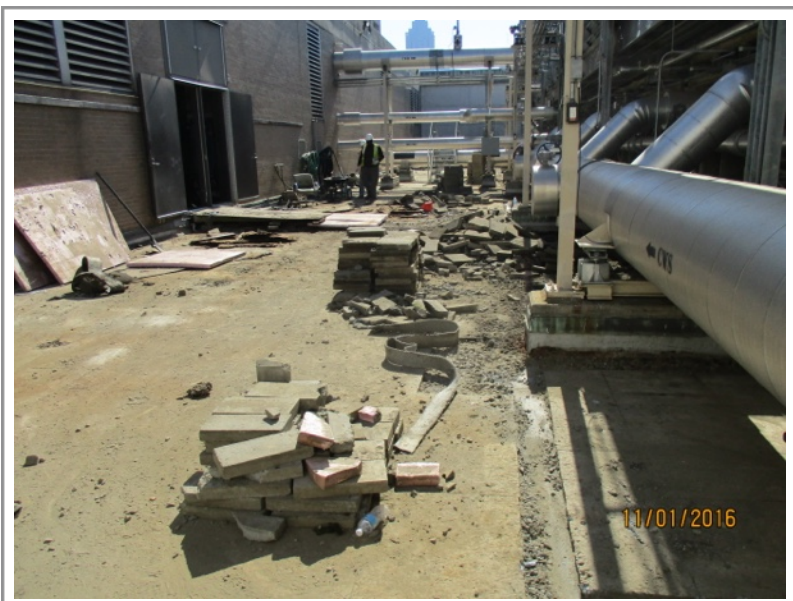
**Removal** ~ First, we began the removal process which included **removing in excess of 200 TONS of ballast, across multiple elevations,** via a vacuum truck as well as approximately **30 TONS of pavers** in the cooling tower area that had to be **hand carried** through the building.

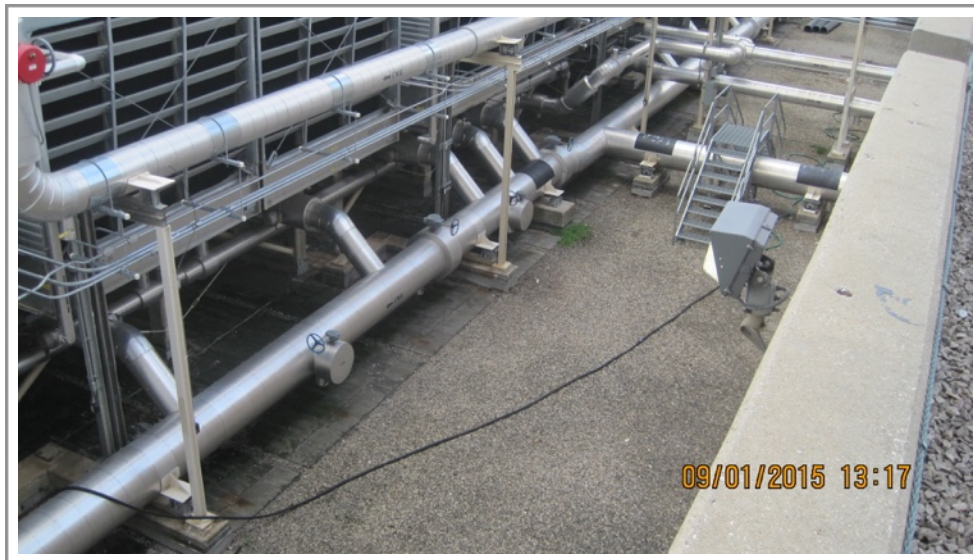
Next we repeated the same process to **remove the 2” extruded polystyrene insulation board**. We then removed extensive areas of loose coal tar pitch and conducted repairs to the barrier. Some of the removal work was challenging due to not just the **multiple elevations** but also the tight areas in the cooling tower area with **clearance enough only to crawl**.

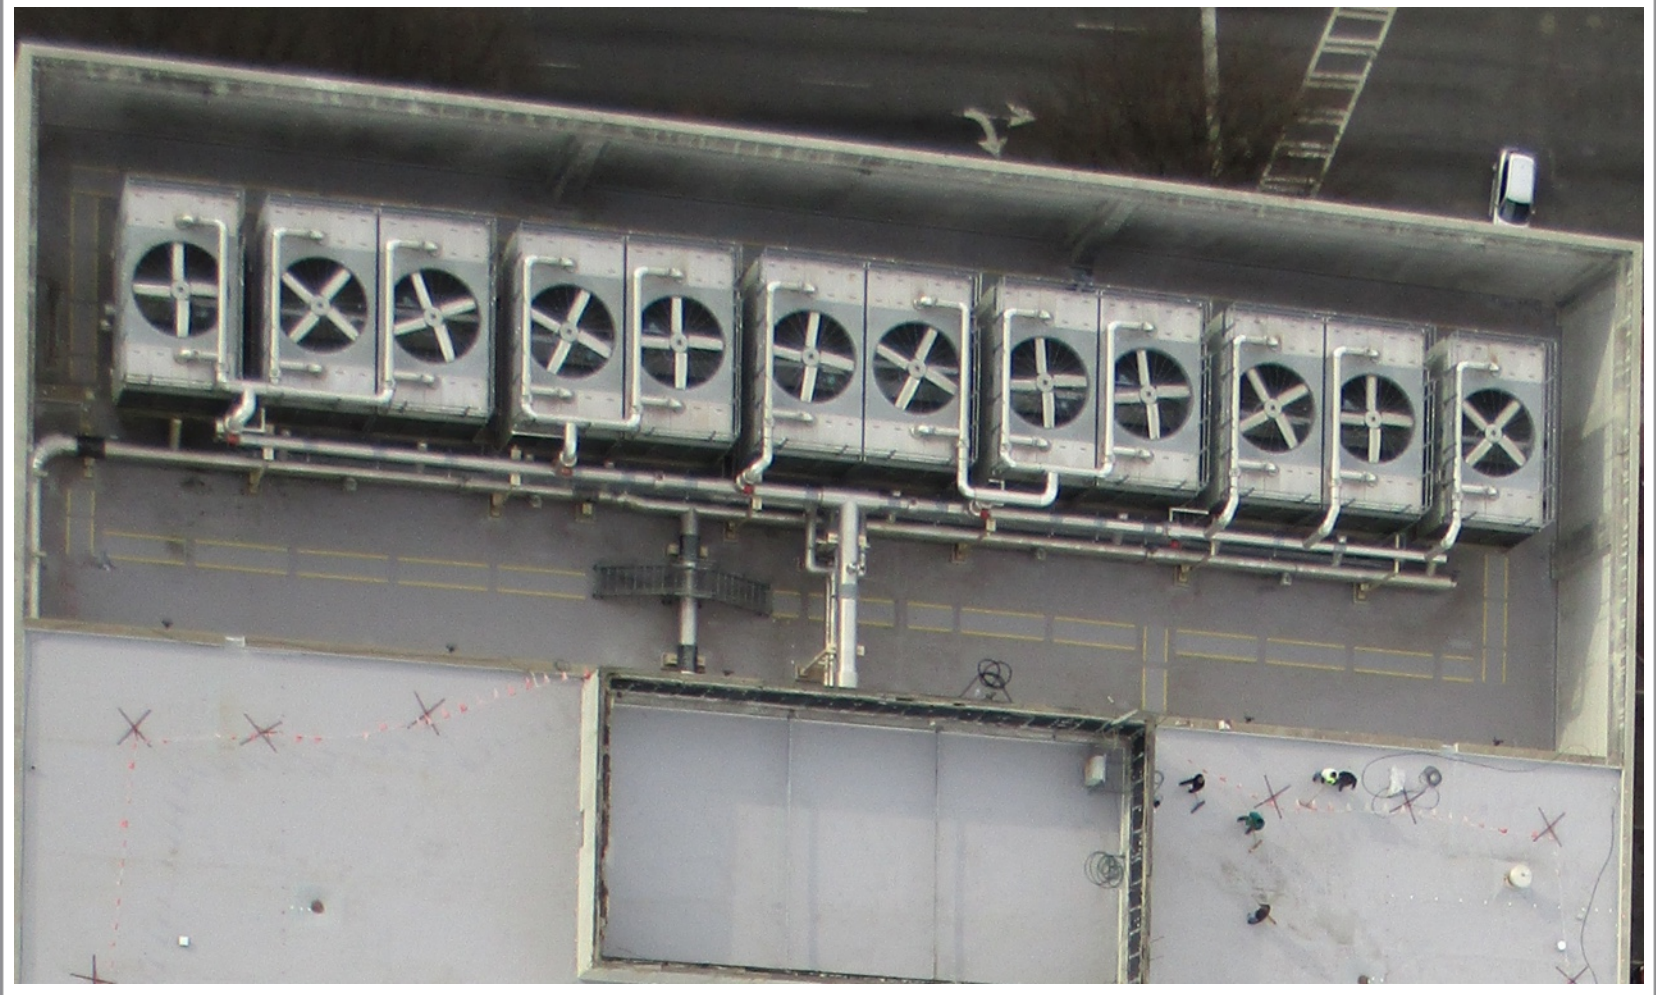
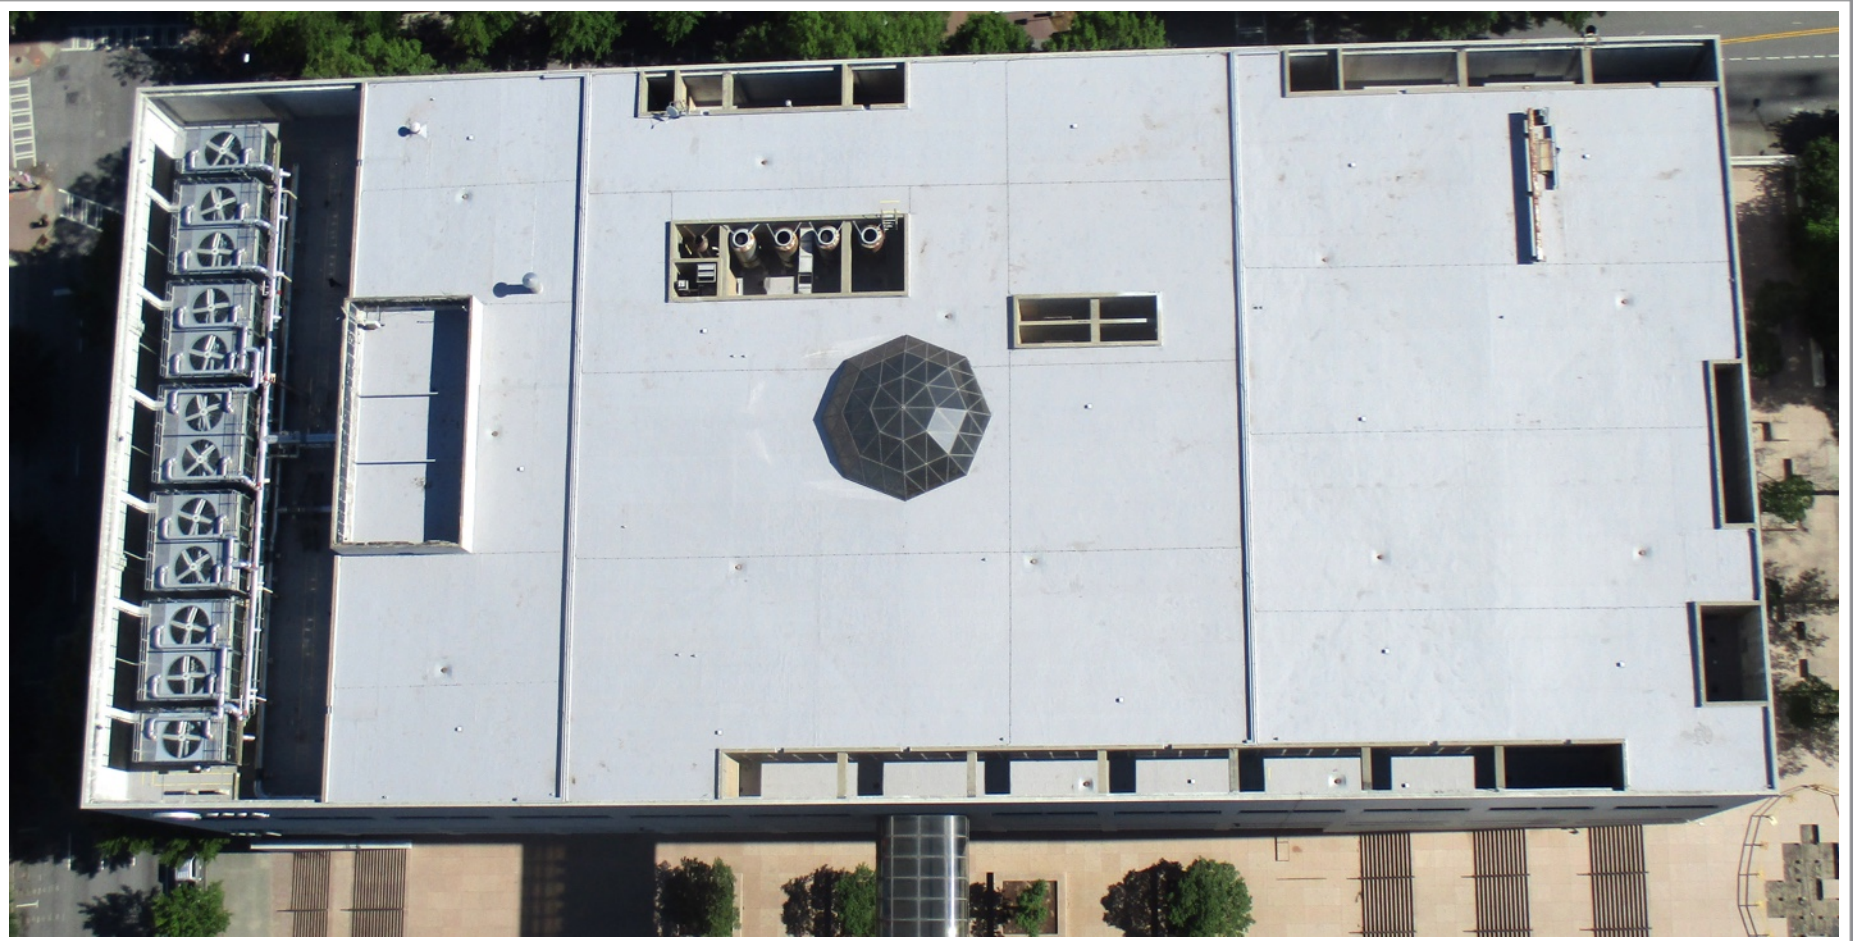
Note: what looks like lines is the lightening protection...
